BANNACK STATE PARK PROJECT

DSL - AMRB No. 91-006

FINAL REPORT

January 27th, 1992

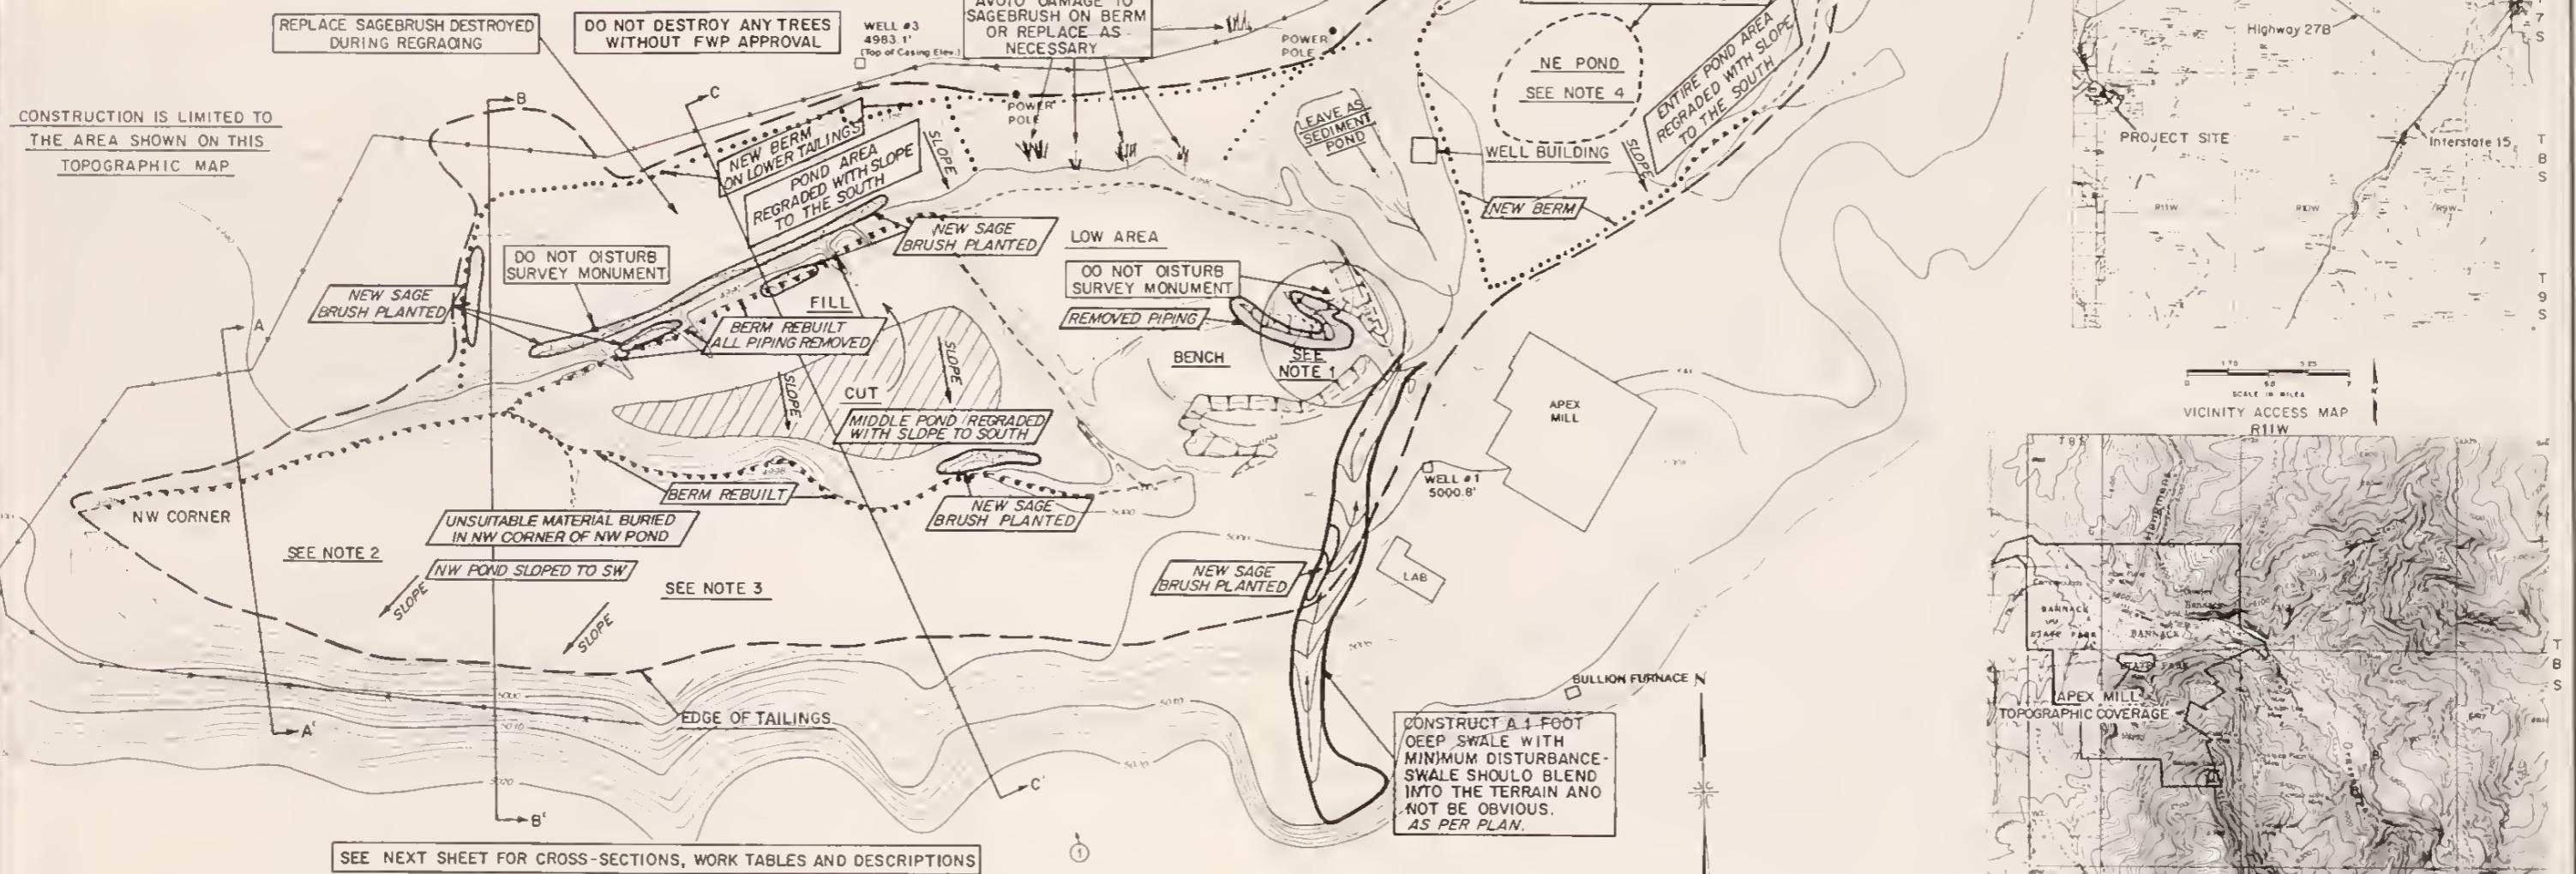
— BOUNDARY OF TAILINGS
- - - CREST LINE OF EXISTING TAILINGS BERMS
- - - - CREST LINE OF TAILINGS - TO BE BUILT OR RECONSTRUCTED

- NOTES**
1. EXCAVATE AND REPLACE TO ELIMINATE PIPING, COMPACT WITH AT LEAST 3 PASSES OF WHEELED VEHICLE. (MUST BE MOIST.)
 2. PUSH AND SPREAD THE NON-TAILINGS MATERIAL INTO THE NW CORNER. (MAXIMUM FILL ELEVATION IS 4993'). COVER THE NON-TAILINGS MATERIAL WITH CUT FROM NOTE 3.
 3. CUT TO COVER NOTE 2 MATERIAL.
 4. UNSUITABLE MATERIALS WHICH HAVE BEEN SPREAD ON TOP OF THE TAILINGS IN THE NE POND WILL BE COLLECTED AND DEPOSITED IN AN EXCAVATED DISPOSAL PIT WITHIN THIS POND AREA. THE UNSUITABLE MATERIALS WILL BE COVERED WITH AT LEAST 1 FOOT OF SUITABLE MATERIAL FROM THE EXCAVATION. TWO FOOT HIGH CONTAINMENT BERMS WILL BE CONSTRUCTED IN THE INDICATED AREAS. THE IMPOUNDMENT AREA WITHIN THE BERMS WILL BE GRADED FLAT.

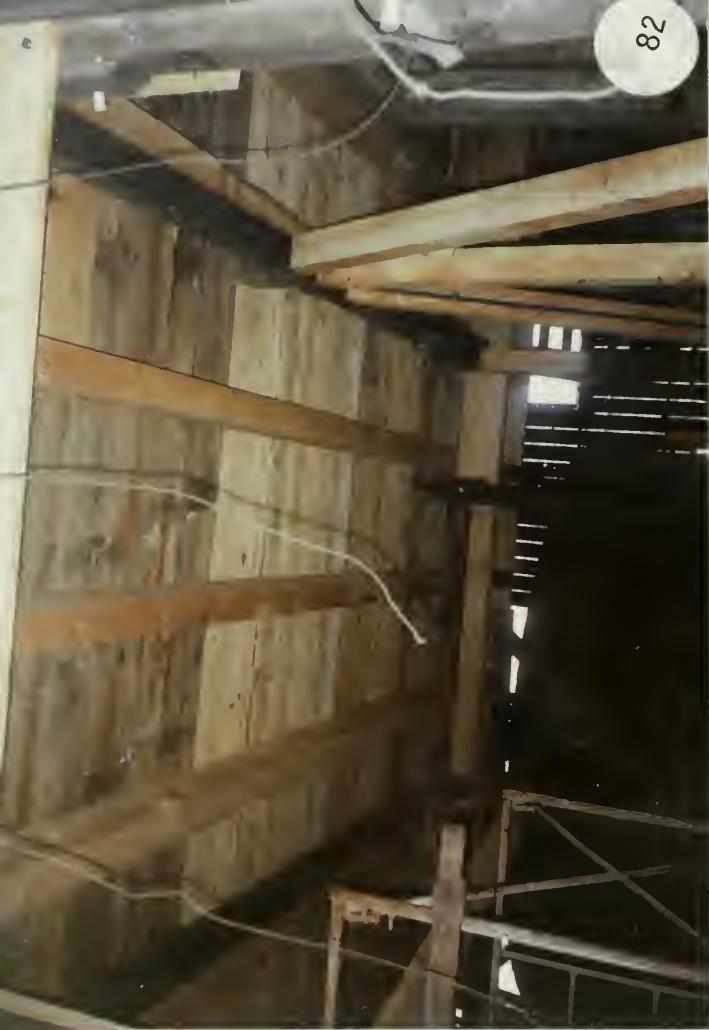
<u>ASSIGNED NUMBER</u>	<u>DATE TAKEN</u>	<u>SUBJECT OR COMMENTS</u>
69	10-15-91	Boiler & maintenance room foundation complete looking northeast
70	09-24-91	Pre-construction view of tank number 3 base looking east
71	09-25-91	Jacking up tank number 3 looking northeast
72	09-25-91	Installing 8x8 posts under tank #3 looking northeast
73	10-15-91	Post-construction view of tank #3 looking east-southeast
74	10-15-91	Installing 6x12 joists upper floor
75	10-15-91	Bolting 6x12's in place looking west
76	10-15-91	All 6x12's in place looking west
77	10-15-91	Re-nailing floor to 6X12 joists looking west
78	10-15-91	Re-nailing floor using old and new planking looking west
79	10-16-91	Installing joists around tank number seven
80	10-16-91	Installing 6 inch lag screws in braces
81	10-16-91	Installing 4x4 and 6x6 under joists for upper floor
82	10-16-91	Tension rods mid-section and bottom of newly completed upper floor
